Analysis of Defects In Solid Rocket Motors Using X-Ray Radiography

S Remakanthan, Moideenkutty KK, R Gunasekaran, Cherian Thomas & C R Thomas

Rocket Propellant Plant, Vikram Sarabhai Space Centre, Trivandrum

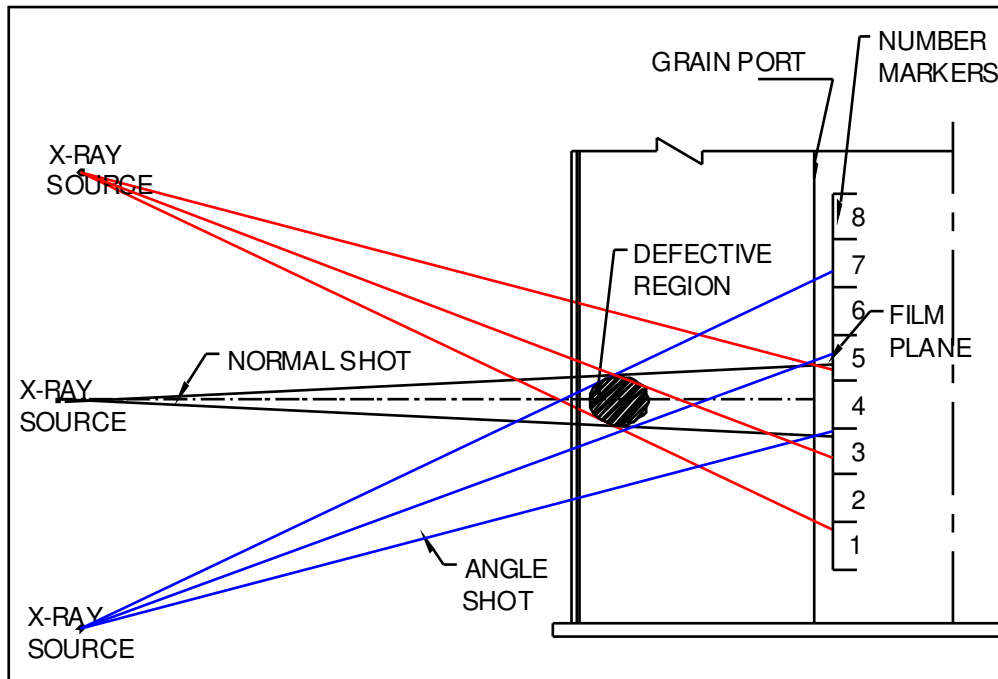
Fig.4 Details of triangulation shots to locate radial extent of void

Normal grain shots reveal the presence of voids if any in the volume covered. For finding the radial location of the voids, triangulation method is followed. In this method additional shots are taken at an angle from below and above the defective region. Then the radial location of the void region can be determined from the three different shots by geometric calculations. Fig 4 describes the details on triangulation shots. Numbers of film markers are kept at 100mm interval and D&U are markers on the motor case corresponding to axial boundary of the defective region as seen in the normal shot. Down shot is centered on D mark and upshot on U mark. From the appearance of defective region in the three shots radial extent at that location can be geometrically estimated.
